## PA/VSİ Or RFA FILE REVIEW CHECKLIST

Facility Name: Aero Plating Works Inc. \_\_\_\_\_

EPA ID: ILD 005 125 836 \_\_\_\_\_ City: Chicago \_\_\_\_\_ State: IL \_\_\_\_\_

**PRELIMINARY ASSESSMENT/VISUAL SITE INSPECTION REPORT  
FOR  
AERO PLATING WORKS  
CHICAGO, ILLINOIS  
EPA ID NO. ILD005125836**

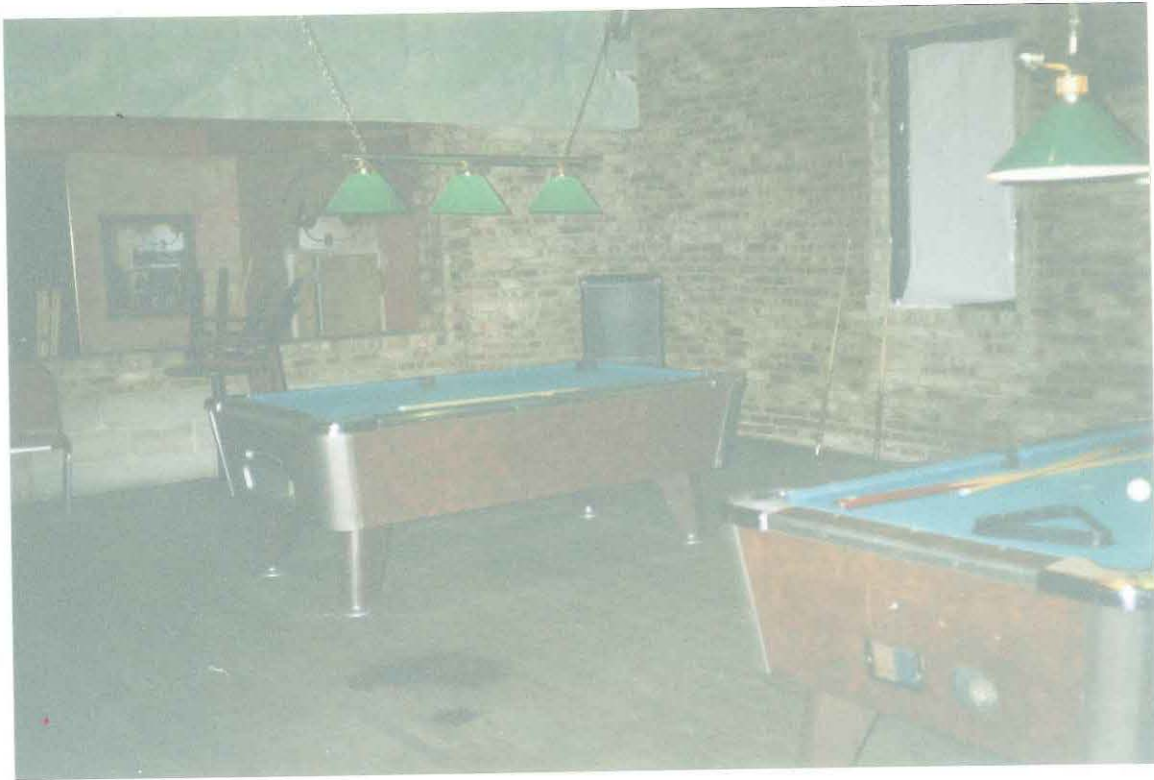
Report Photo No.: 1  
Log Book Photo No.: 1-7  
Date: December 29, 1997

Description: View of the location of the Former Hazardous Waste Storage Area (SWMU 1) located in the southwest portion of the 1850 N. Elston address.

Soil samples taken from beneath the concrete floor at the Former Hazardous Waste Storage Area (SWMU 1) exceeded Soil Screening Levels (SSLs) for lead, copper, and nickel. Initially, it was planned that this soil would be removed to remediate the area. Soil borings performed to delineate the contamination discovered what appeared to be a floor beneath the soils. This was reported in a letter from ACES Maintenance to the IEPA, dated November 8, 1995. Based on the apparent containment of the contaminated soils combined with the relatively low levels of contamination and the regional geology, the IEPA approved closure of this area without removal of the soils. Institutional controls were required as part of the closure.

**Conclusions:** Although soils exceeding SSLs were left in place at this unit, the IEPA has approved closure of the unit with institutional controls. Therefore, no further investigation is recommended for this unit.

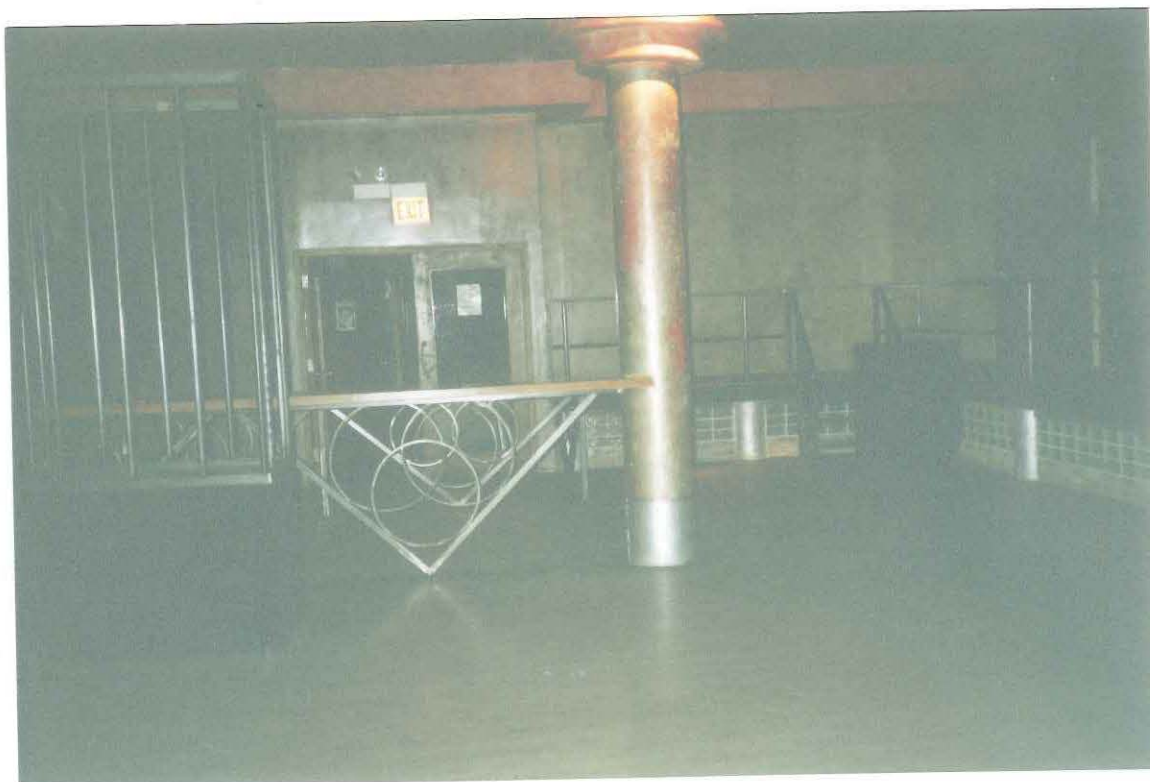
Report Photo No.: 2  
Log Book Photo No.: 1-8  
Date: December 29, 1997

Description: View of the Former Waste Water Pretreatment Area (SWMU 2) located in the northeast corner of the 1850 N. Elston address.

In the Former Waste Water Pretreatment Area (SWMU 2), lead was detected above the SSL in soil samples collected from borings in the area of this unit. As with the Former Hazardous Waste Storage Area (SWMU 1), the IEPA approved closure of this area without removal of the soils. Institutional controls were required as part of the closure.

**Conclusions:** Although soils exceeding SSLs were left in place at this unit, the IEPA has approved closure of the unit with institutional controls. Therefore, no further investigation is recommended for this unit.

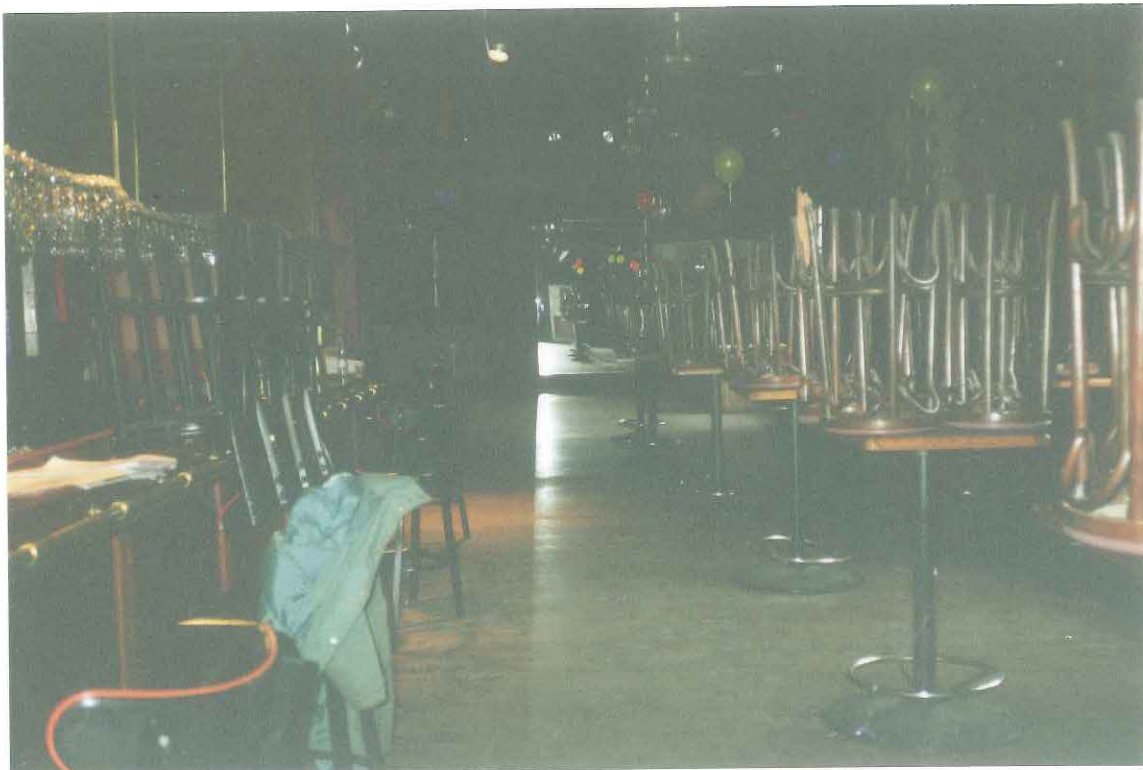
Report Photo No.: 3  
Log Book Photo No.: 1-5  
Date: December 29, 1997

Description: View of the first floor of the 1860 N. Elston address. This is the former location of the Former Nickel Plating Line (SWMU 3). The Former Basement Hazardous Waste Storage Area (SWMU 4) was located towards the back of this photo near the mirror. Note that the area is currently part of the restaurant/night club.

**Conclusions:** There has been no reported release at this unit. At the time of the VSI, there was no visible evidence that any release had occurred. Therefore, no further sampling or investigation is recommended at this unit.

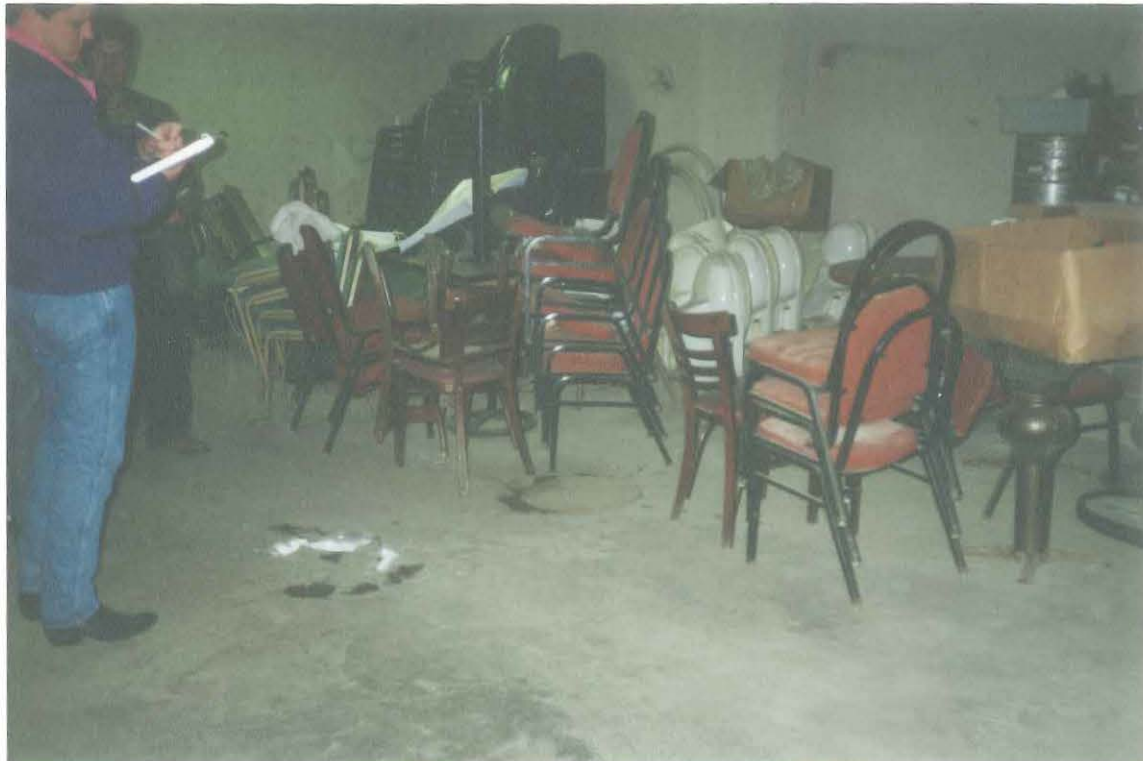
Report Photo No.: 4  
Log Book Photo No.: 1-11  
Date: December 29, 1997

Description: View of the western-most room of the basement at the 1860 N. Elston address.  
This is the location of the Former Metal Stripping Tanks (SWMU 5).

**Conclusions:** Although soils exceeding SSLs were left in place at this unit, the IEPA has approved closure of the unit with institutional controls. Therefore, no further investigation is recommended for this unit.

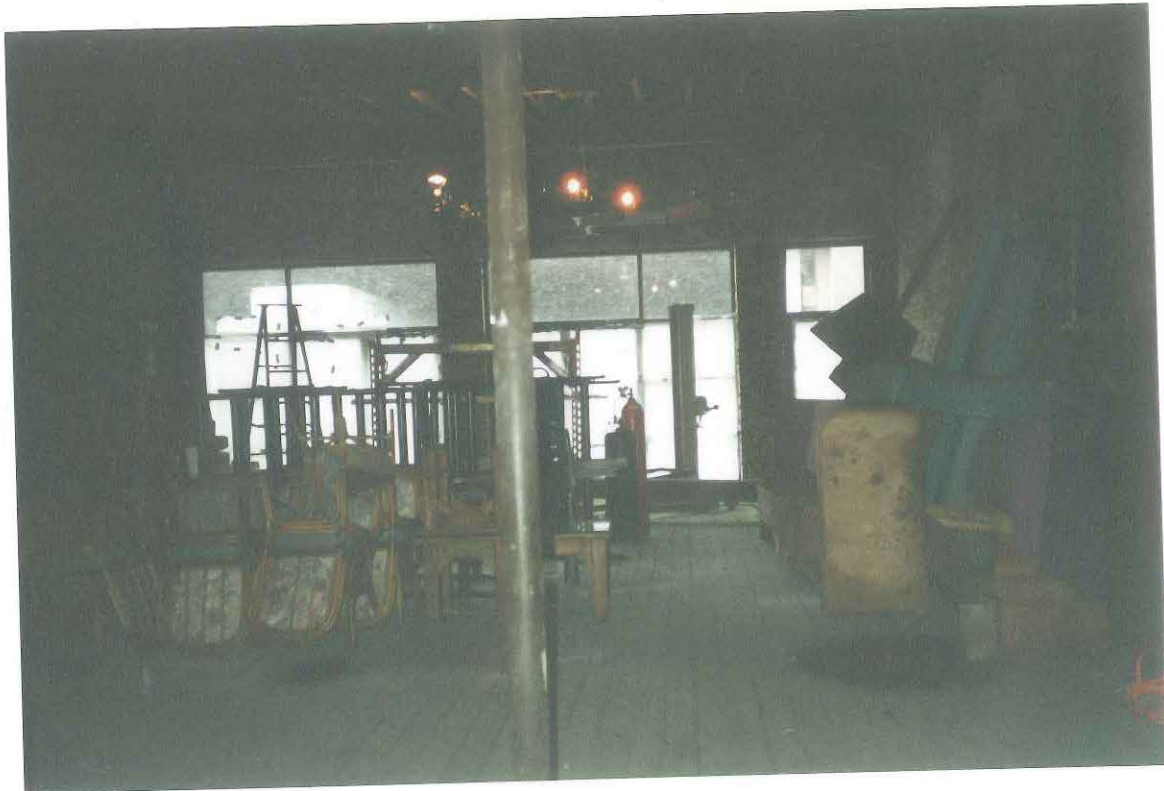
Report Photo No.: 8  
Log Book Photo No.: 1-4  
Date: December 29, 1997

Description: View of the second floor of the 1860 N. Elston building. No industrial activities were performed by Aero Plating on the second floor. As shown in the photograph, the second floor is currently part of the restaurant/night club.

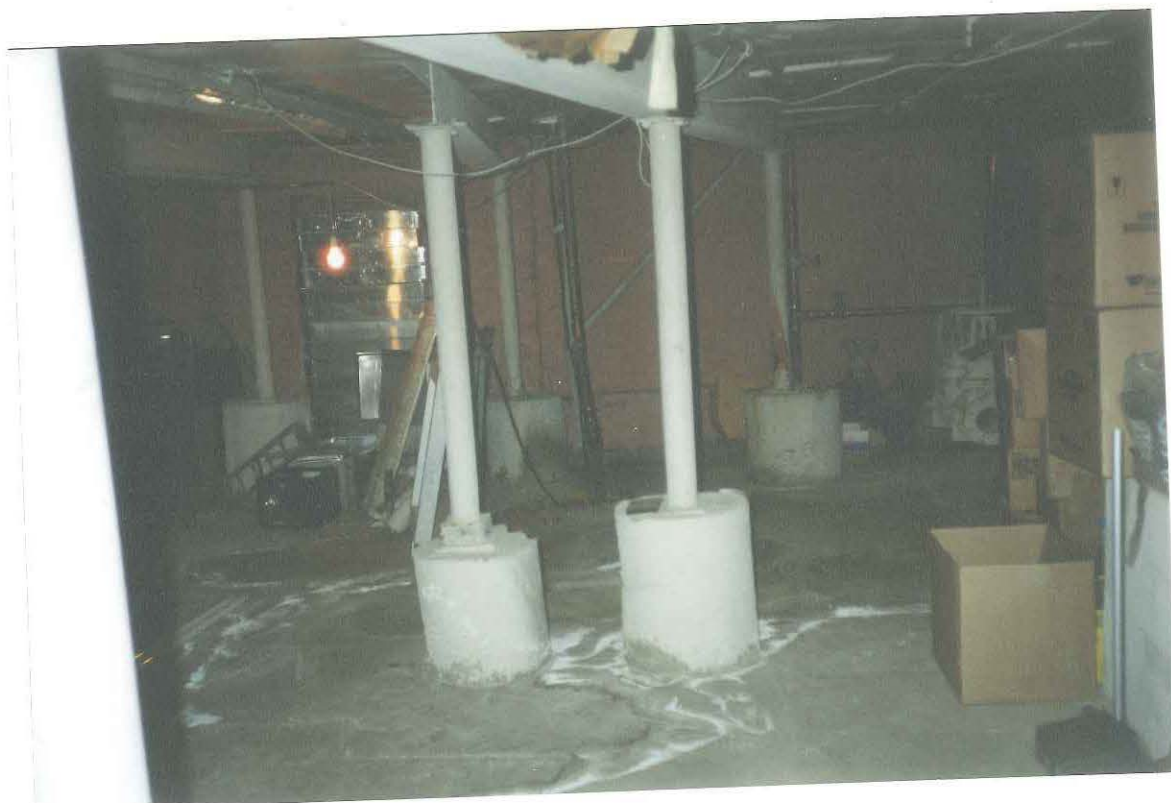
Report Photo No.: 9  
Log Book Photo No.: 1-6  
Date: December 29, 1997

Description: View of the former truck loading/unloading dock area located in the southwest corner of the 1850 N. Elston address.

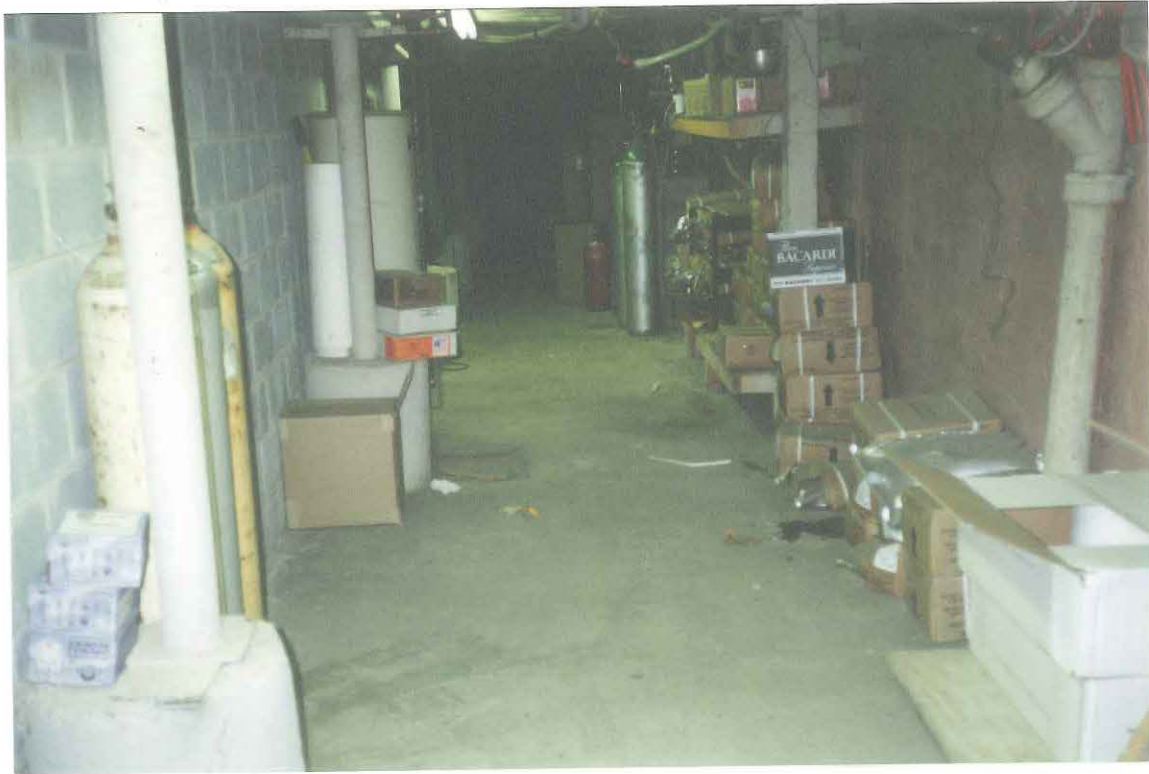
Report Photo No.: 10  
Log Book Photo No.: 1-9  
Date: December 29, 1997

Description: View of eastern most section of the basement at the 1860 N. Elston address.
